FACILITY CONDITION ASSESSMENT

SHERIFF'S OFFICE #5045

106 Edwards Ferry Road

Date of Report: June 25, 2007

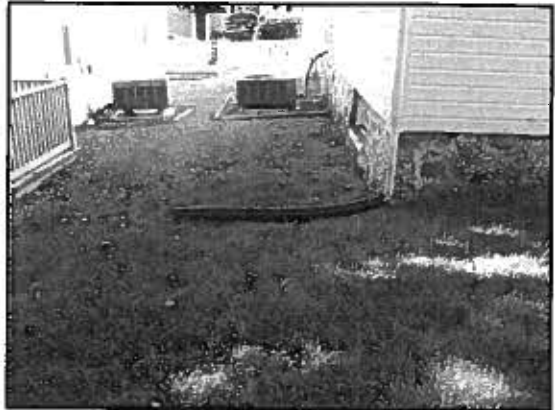
- The topography and adjacent uses do not appear to present conditions detrimental to the property.
- The landscape materials are in good condition and will require routine maintenance during the assessment period.

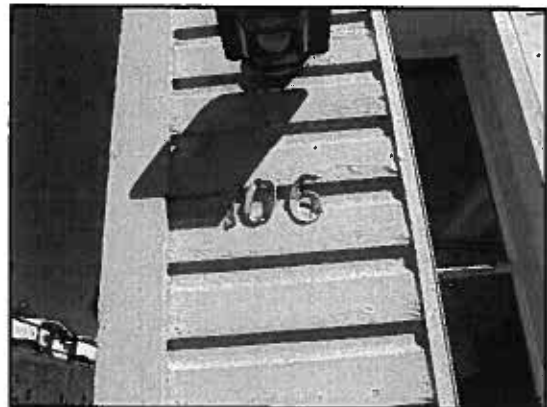
- The property address numbers are in good condition. Routine maintenance will be required during the assessment period.
- The exterior light fixtures are in good condition. Routine maintenance will be required during the assessment period.

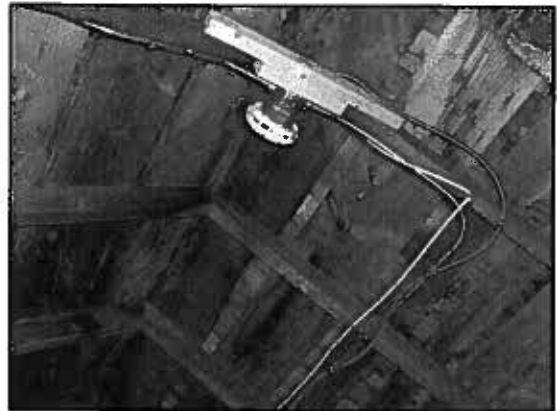
- The superstructure is exposed in some locations, which allows for limited observation. Walls and floors appear to be plumb, level, and stable. There are no significant signs of deflection or movement.

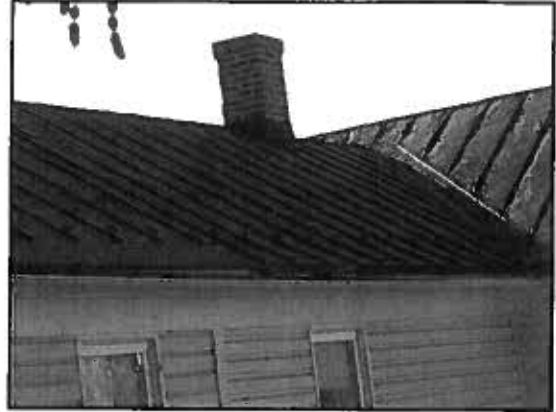
- The property does not have a dedicated roof repair and maintenance contractor. County maintenance maintains the roofs or a contractor is retained when required.

- Roof drainage appears to be adequate. Clearing and minor repair of drain system components should be performed regularly as part of the property management's routine maintenance program.

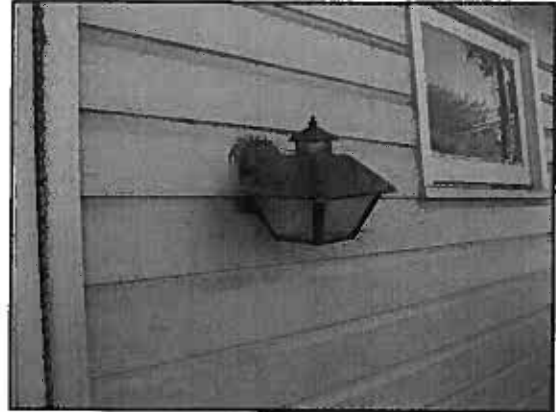
- The exterior finishes are in fair condition. The wood trim and boards are showing wear throughout. Replacing worn boards and trim, painting and patching of the wood lap board siding and trim will be required during the assessment period. The estimated cost of this work is included as a lump sum in the Deficiency Cost Table and is considered a Priority 2 corrective action.
- The sealant is in fair condition. There are isolated areas of brittle, deteriorated, and missing sealant along the east and north elevations of the building. The damaged sealant must be replaced. Because this cost is not significant, it is included with the cost to paint the trim, windows and doors

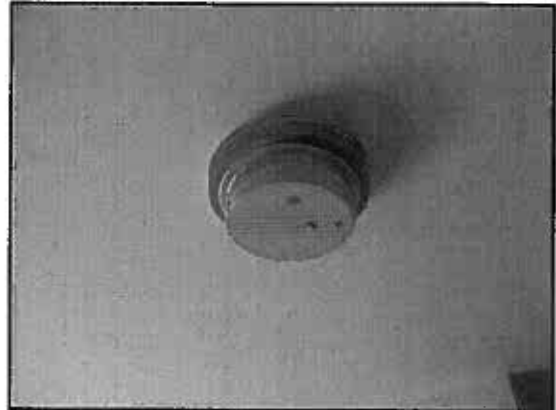
- Smoke detector replacement is considered to be routine maintenance.
- The dry chemical extinguishing systems appear to be in good condition and are serviced regularly by a qualified fire equipment contractor.
- The pull alarms appear to be in good condition and will require routine maintenance during the evaluation period.

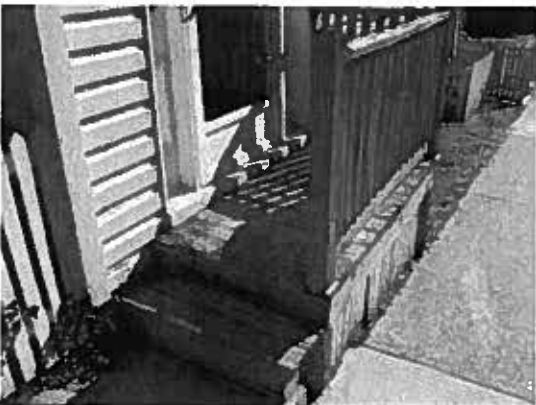
Photo #5: Non-ADA compliant entrance

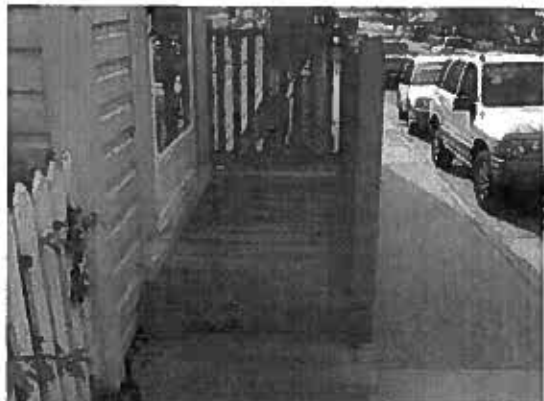
Photo #12: Front exterior stairs showing wear

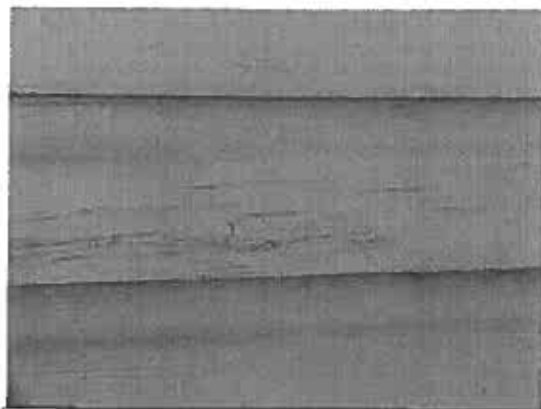
Photo #14: Splintering and weathered exterior siding

6.4	Replace wood siding and trim	30	29	1	2800	sf	\$3.75	\$10,500.00	\$0.00	\$10,500.00	\$0.00	\$0.00	\$0.00	\$0.00	\$0.00	\$0.00	\$0.00	\$0.00	\$0.00	\$0.00	\$0.00	\$0.00	\$0.00	\$0.00	\$0.00	\$0.00	\$0.00	\$0.00	\$10,500.00

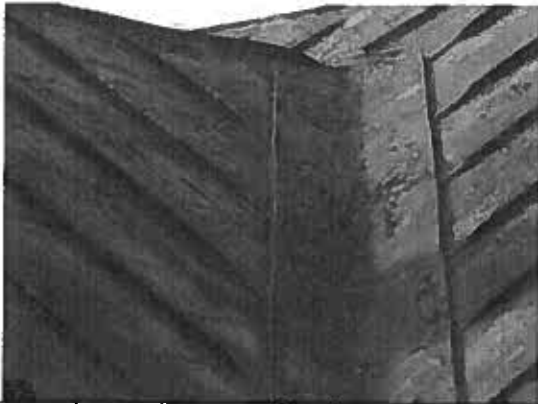
Photo #15: Metal roof showing signs of rusting

6.3	Replace corrugated metal roofing	25	24	1	1400	sf	\$3.25	\$4,550.00	\$0.00	\$4,550.00	\$0.00	\$0.00	\$0.00	\$0.00	\$0.00	\$0.00	\$0.00	\$0.00	\$0.00	\$0.00	\$0.00	\$0.00	\$0.00	\$0.00	\$0.00	\$0.00	\$0.00	\$0.00	\$4,550.00
